# Michigan SHPO Architectural Properties Identification Form

| Street Address | 76 North Main Street | | | | |
| City/Township, State, Zip Code | Clarkston, Michigan 48346 | | | | |

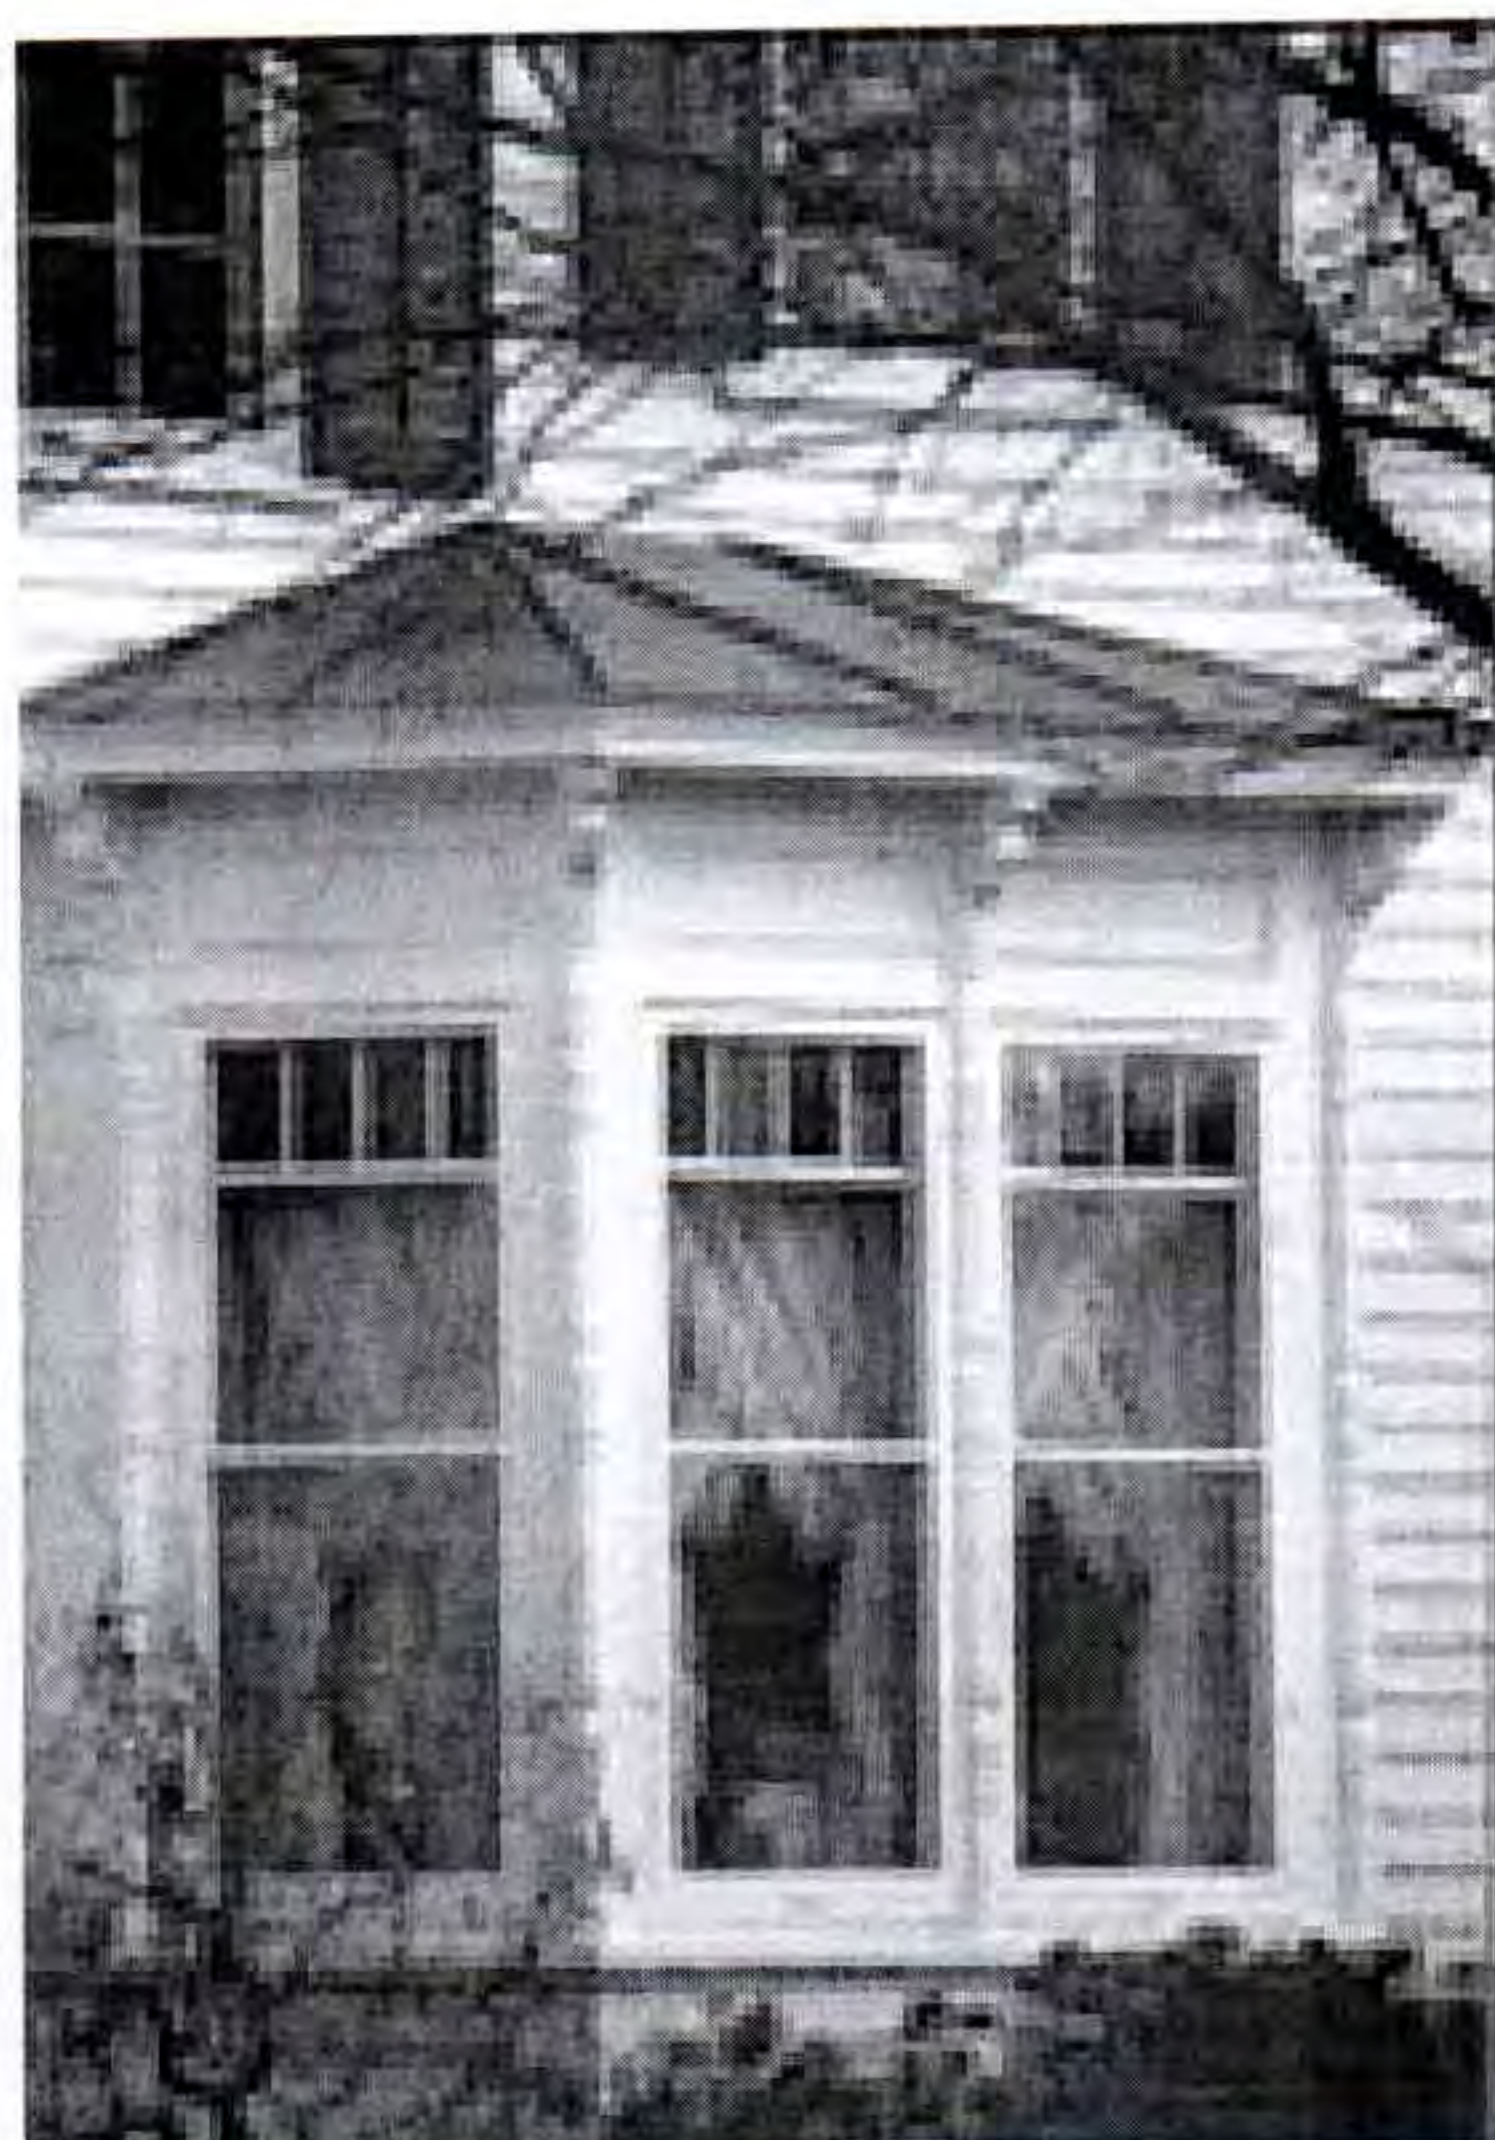
The house has a front gabled roof emphasized with a wide trim (undecorated boards). The front door has narrow sidelights (four on each side) with broken transom light and a simple enframement. The windows in the original part of the house are four over four wooden double hung with dark green shutters. The canted bay (southwest corner of the west elevation) has a total of four one-over-one double hung windows, each with four small lites at the top. Two of these windows are in the front with one on each side of the bay. There are traditional wooden cornice brackets supporting a copper low pitched roof.

The front façade (west elevation) is still Greek Revival, but the house has a one-story L-shaped addition to the north modifying the look of a traditional Greek Revival house. The addition across the west elevation (shorter section of the L) has three one-over-one double hung windows; the longer section of the L shaped addition facing north has five double hung windows of varying sizes all one-over-one; the inside of the L shaped addition has three six-over-six double hung windows; the east elevation has two six-over-six double hung windows. All windows have dark green shutters.

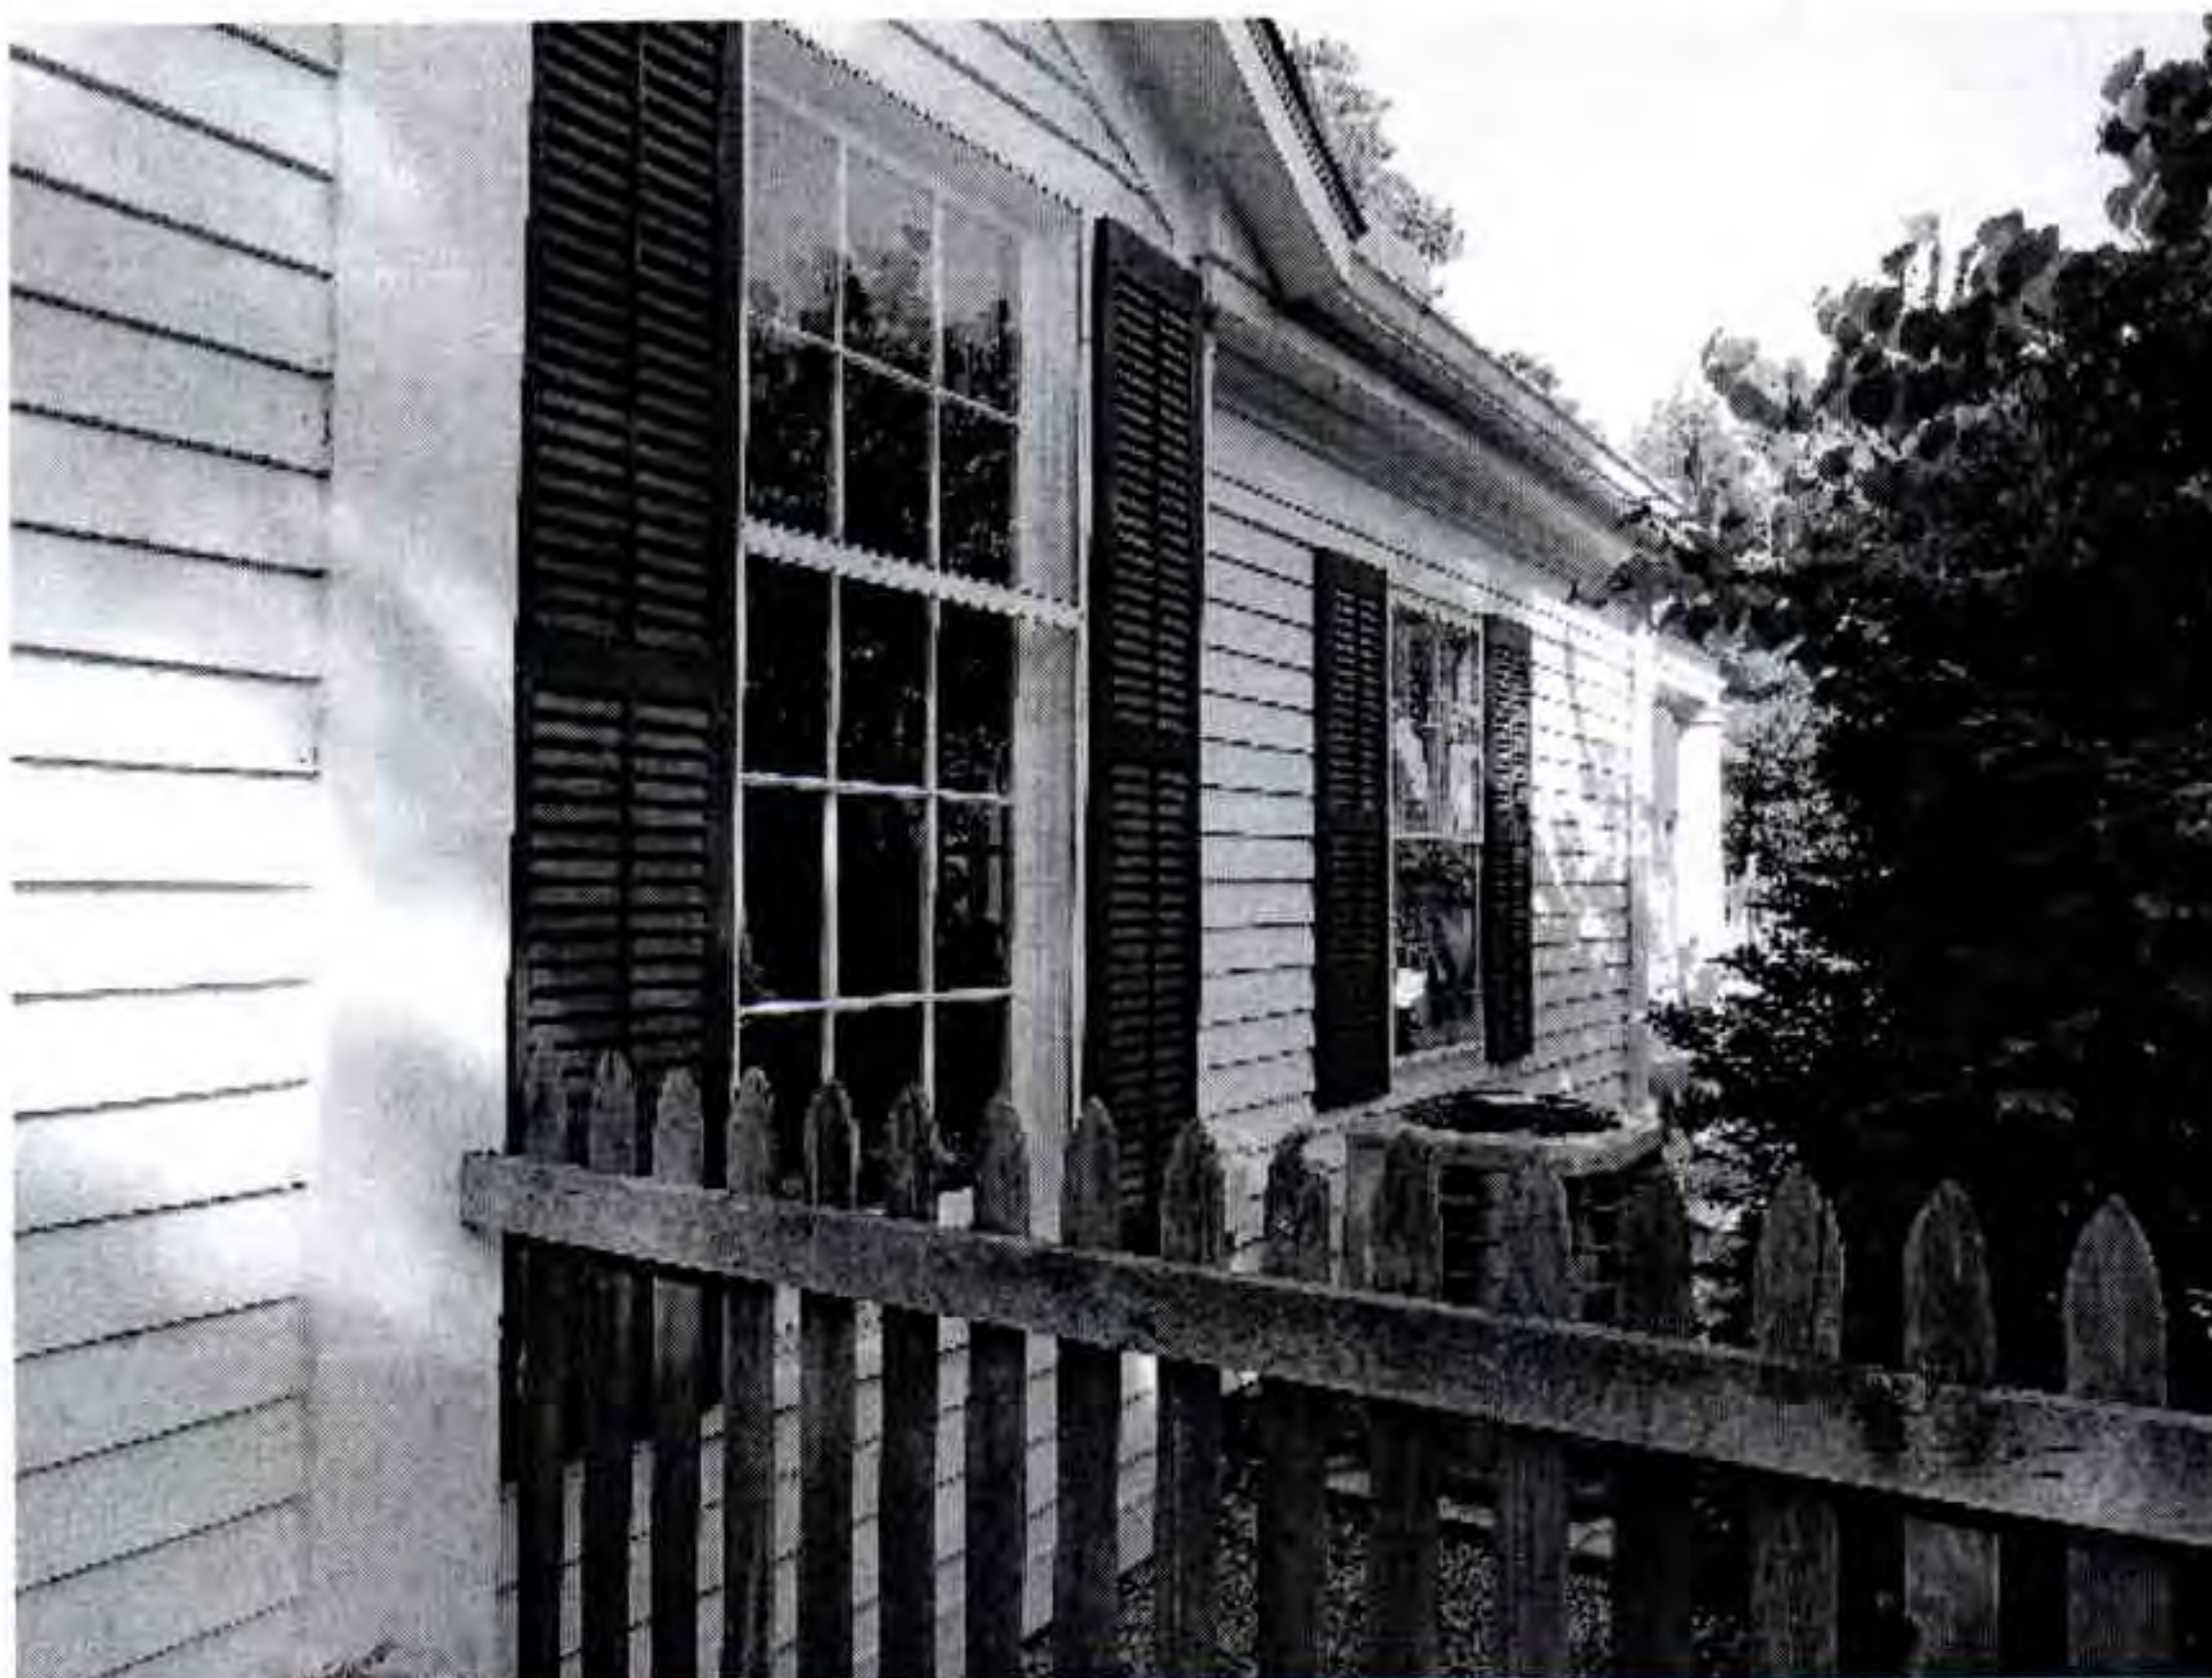
(south elevation east corner)

A one-story kitchen was added to the southeast (back) of the house in the 1980s and then in 2004 the kitchen was expanded, and a one-story porch was added. The kitchen addition in the 1980s (south elevation) has a large fifteen pane window with dark green shutters. The 2004 addition kitchen window has a six over six double hung window with dark green shutters on the south elevation.

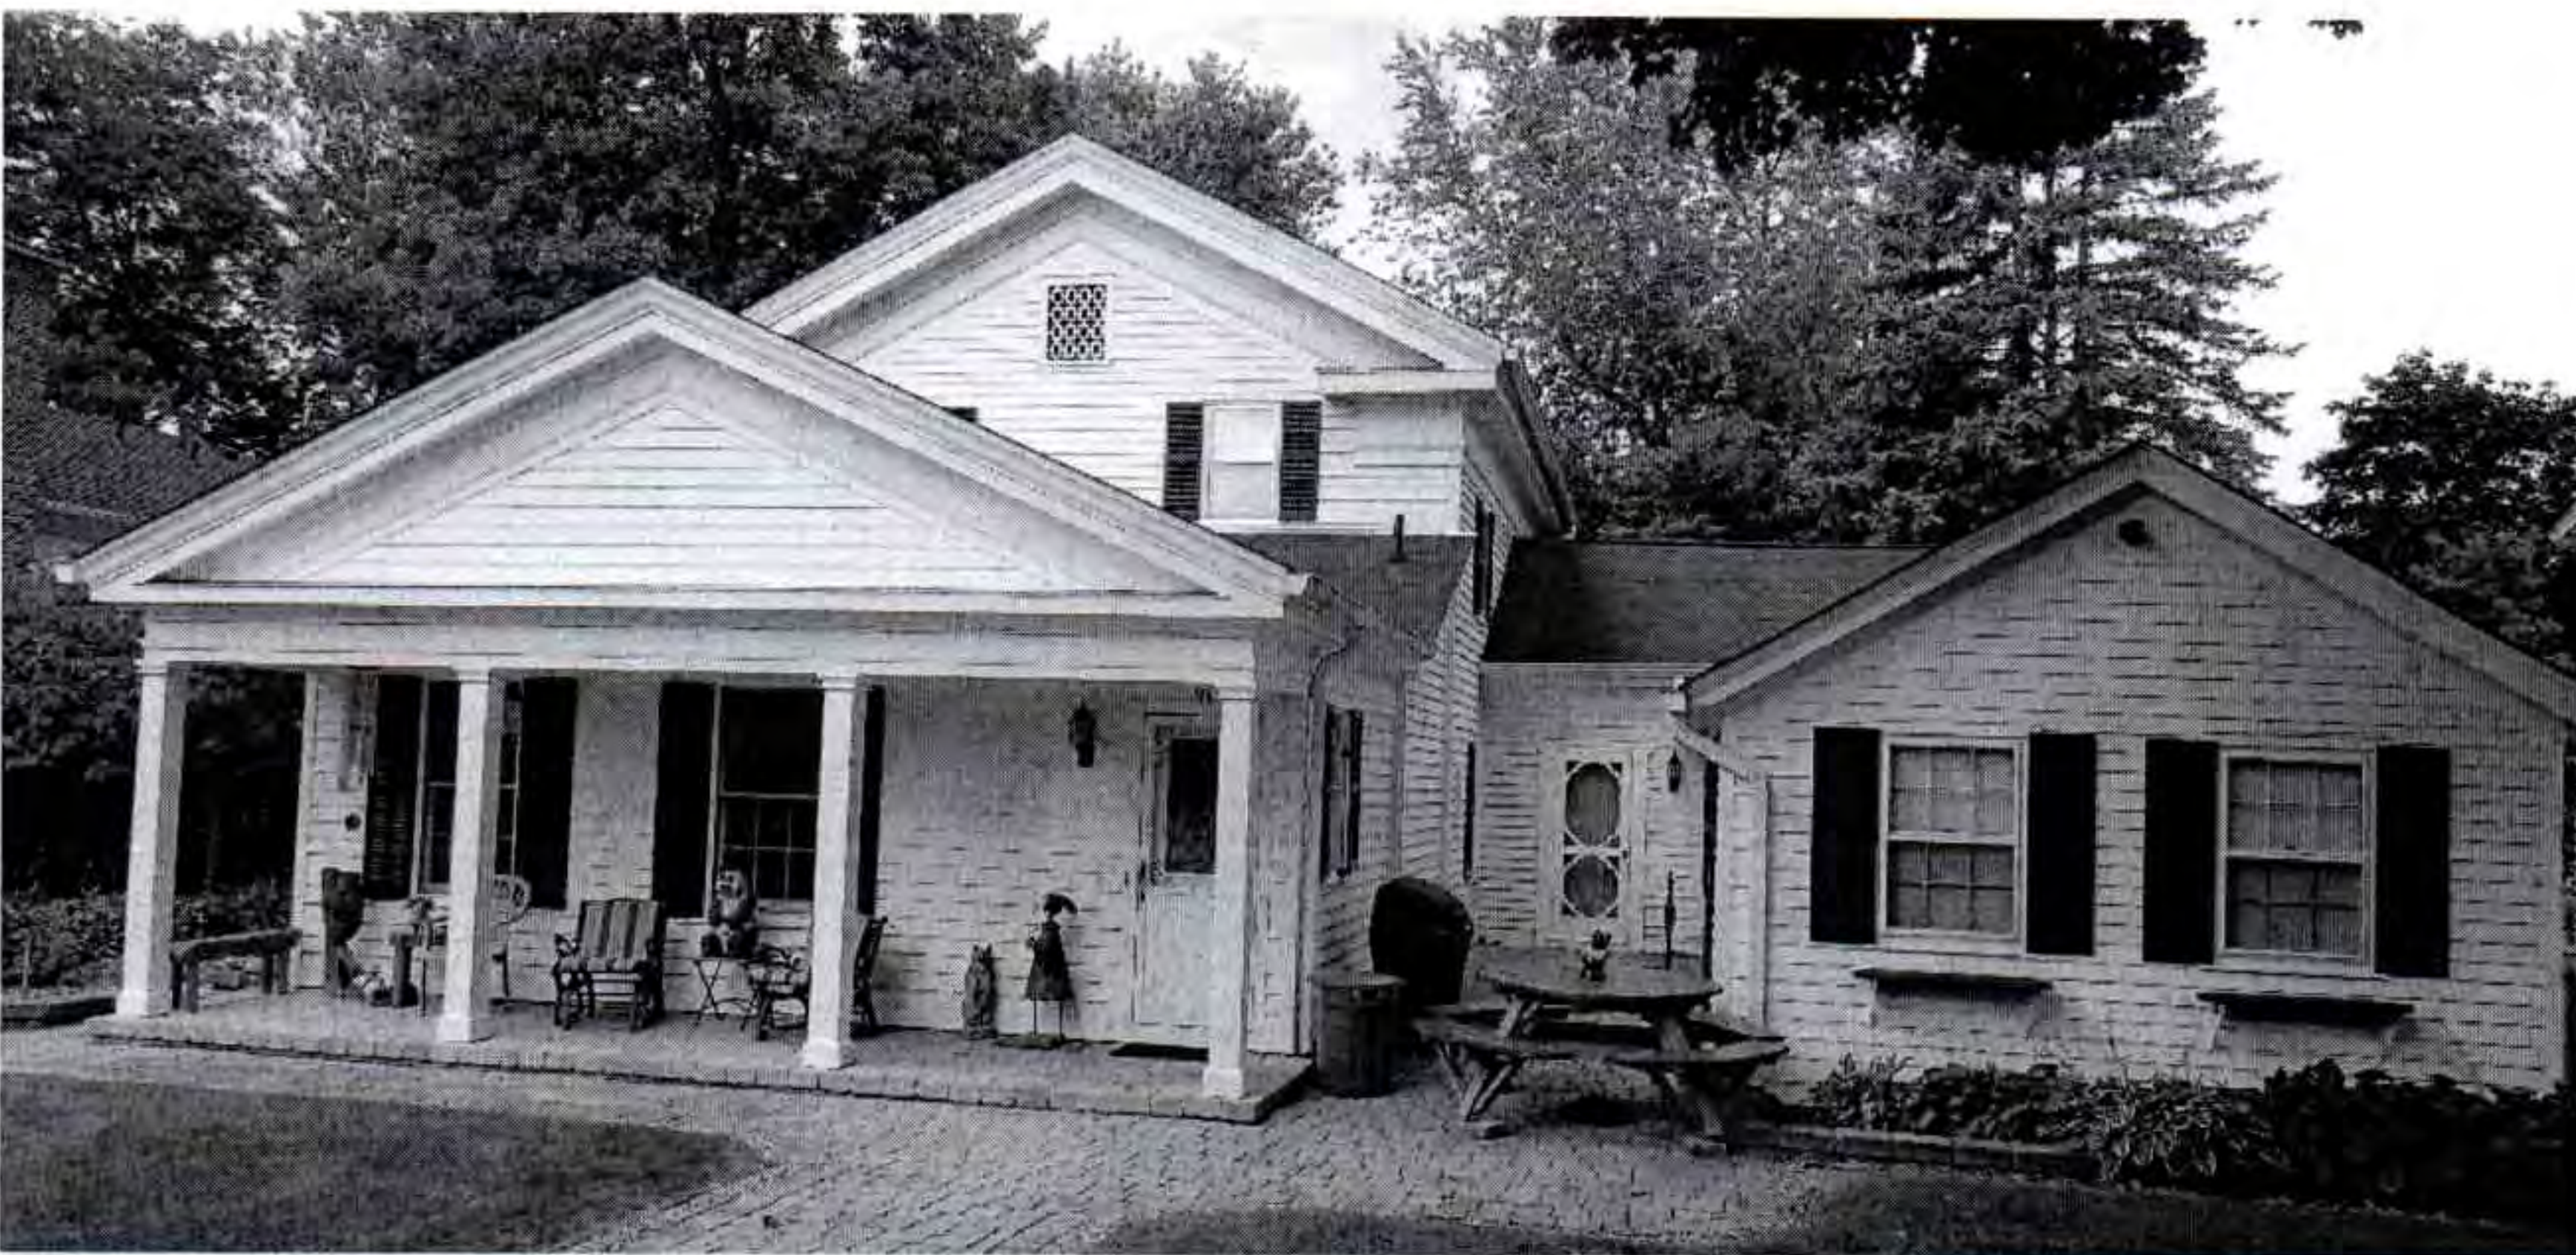
(east elevation)

The addition on the north and south both extend toward the east complicating the east elevation. These additions result in a small courtyard between them that is open ended toward the east. At the closed end of the courtyard is an entryway door of solid wood panels that enters into the original house first floor. Within the courtyard, there is a south facing side of the north addition that has a pair of six over six double hung windows near the west (closed) end and a solid wood door near the east end. Also within the courtyard, the north facing side of the south (kitchen) addition has a single six over six double hung window near the east end.

The second floor of the east elevation of the original house is still visible above the south side addition and shows two six over six double hung windows and a large gable vent with decorative lattice work near the gable peak.

Beneath this is the (south end) kitchen addition showing east elevation porch one step up from the ground level. The steep gable roof of the porch is supported by four square posts/columns. There are two six over six double hung windows, one in the middle and one toward the south end. On the north end is an entryway door.

The east elevation of the north addition shows two six over six double hung windows with box shelves.
